***Hickman Road over the Tuolumne River Bridge
Replacement Project*** ***BA***

Biological Assessment

Stanislaus County, California

Federal Project No. BRLS-5938(199)

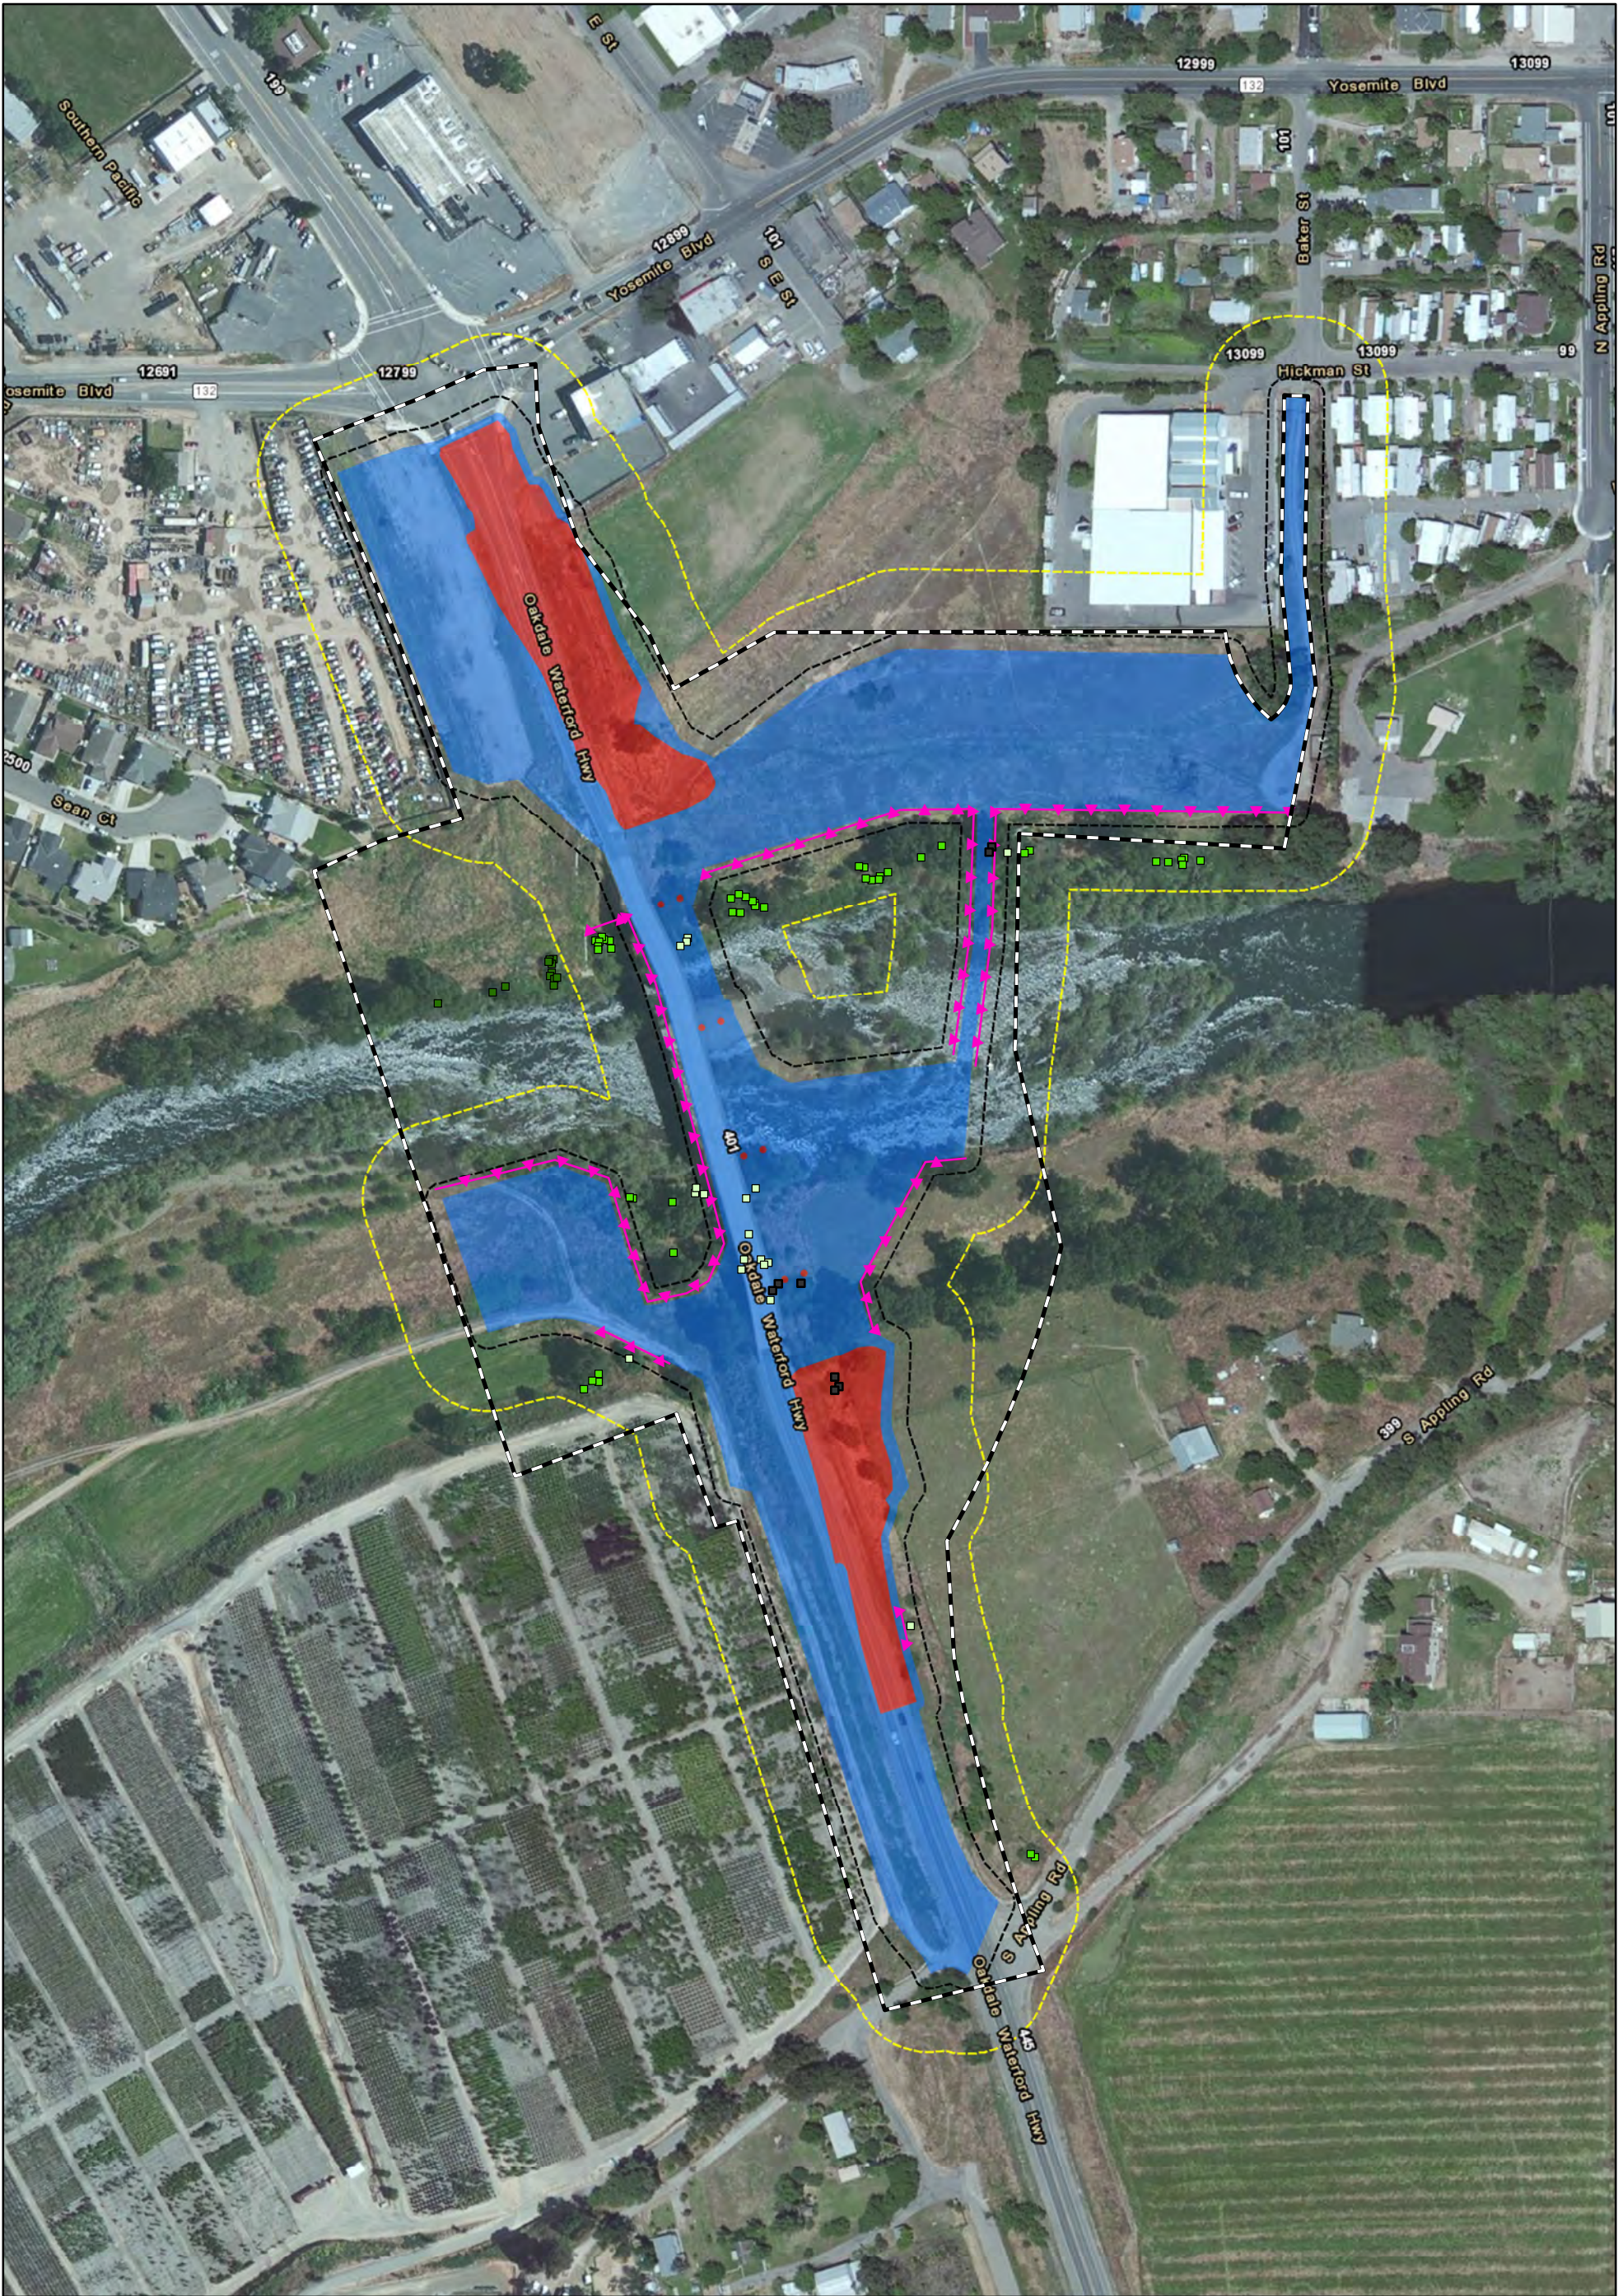
Hickman Road Bridge (38C0004) Replacement Project
Stanislaus County, California
10-STA-0-CR
Federal Project No. BRLO-5938 (199)
Elderberry Locations and ESA Fencing

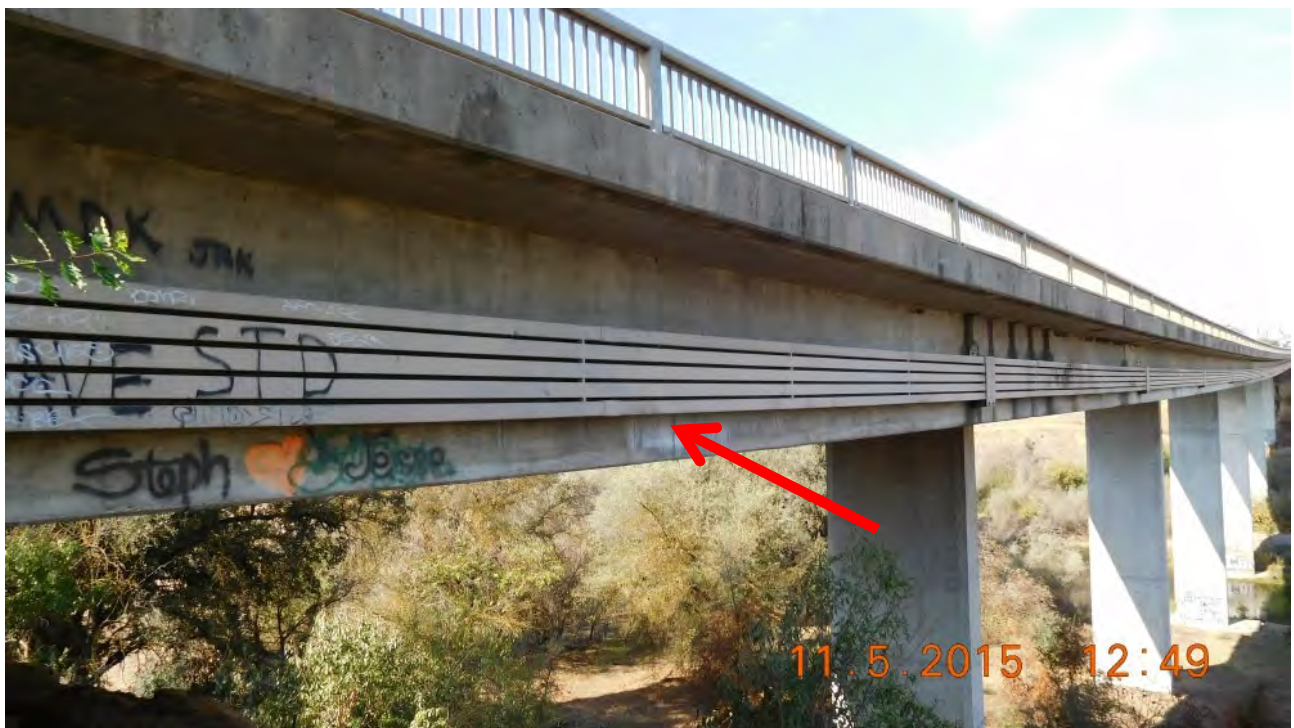
Figure 2. View from south end of bridge. Dead bat observed in roost crevice behind utility channel assembly at arrow.

Wildlife Research Associates bat specialist Greg Tatarian conducted a daytime habitat assessment and bridge survey on November 5, 2015. The survey involved the use of a high-powered spotlight, spotting scope and binoculars to survey the existing bridge structure. There results of the survey and recommended avoidance measures are included in Appendix F.

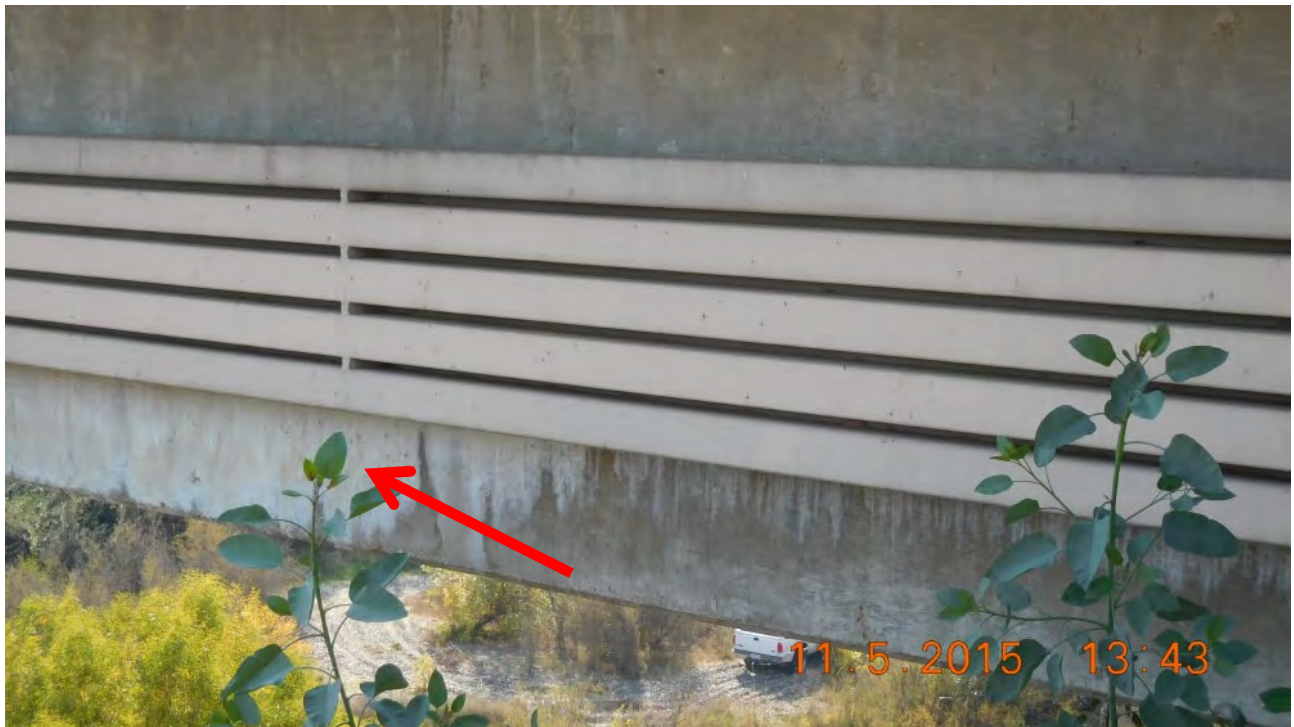
Figure 3. Extensive areas of bat urine staining and bat fecal matter on soffit behind, beneath, and on utility channel assembly.

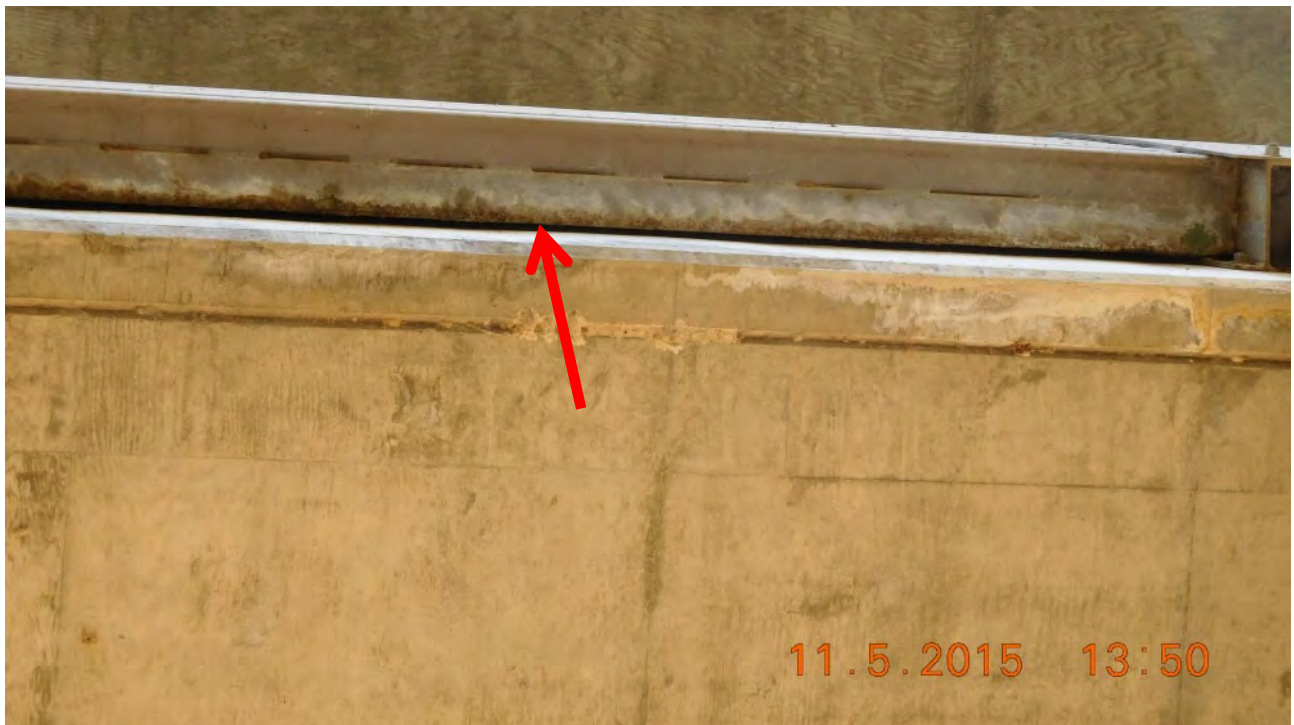
Figure 4. Urine staining indicates use by many bats over many years.

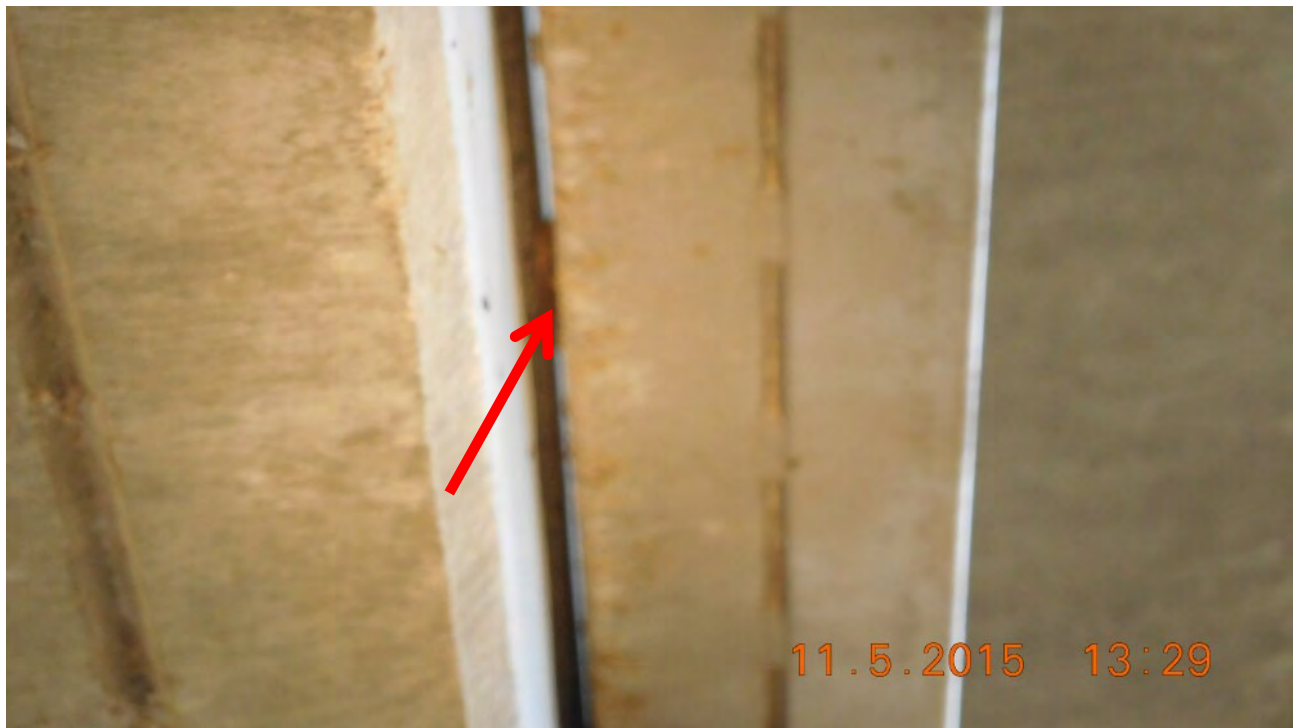
Figure 5. Dead bat visible with binoculars and light, but poor photo.

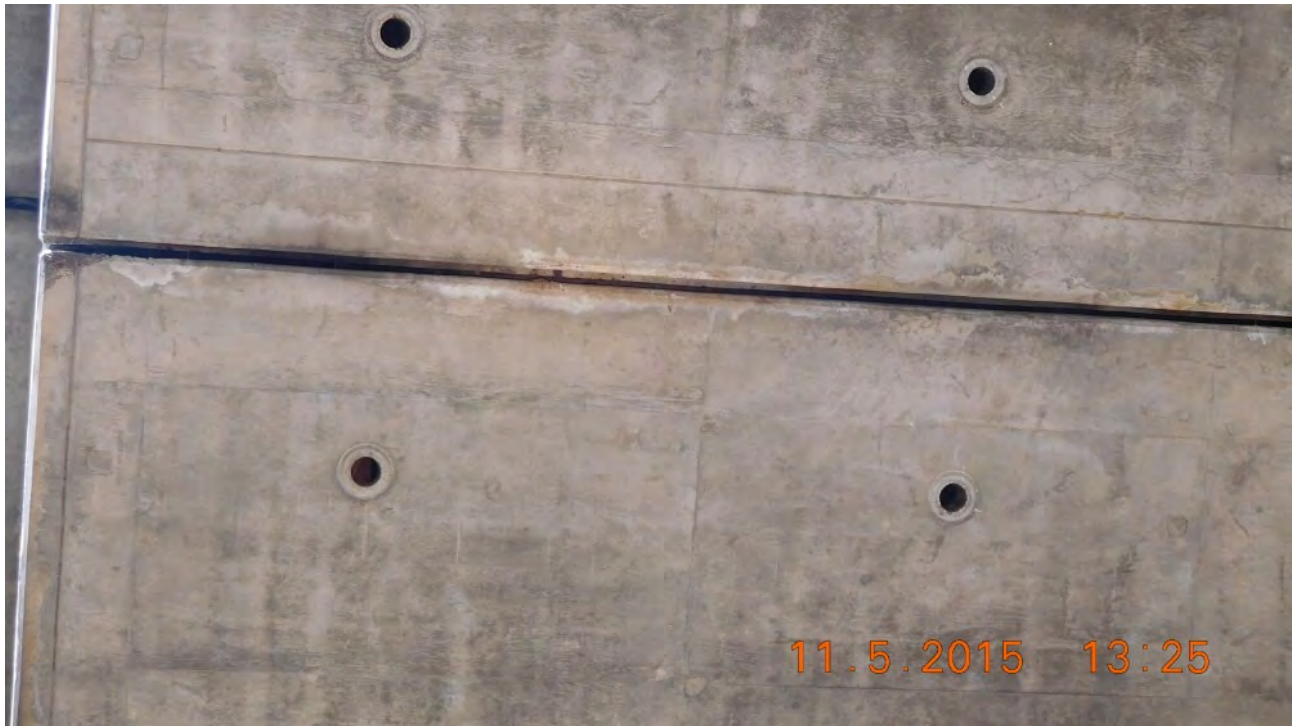
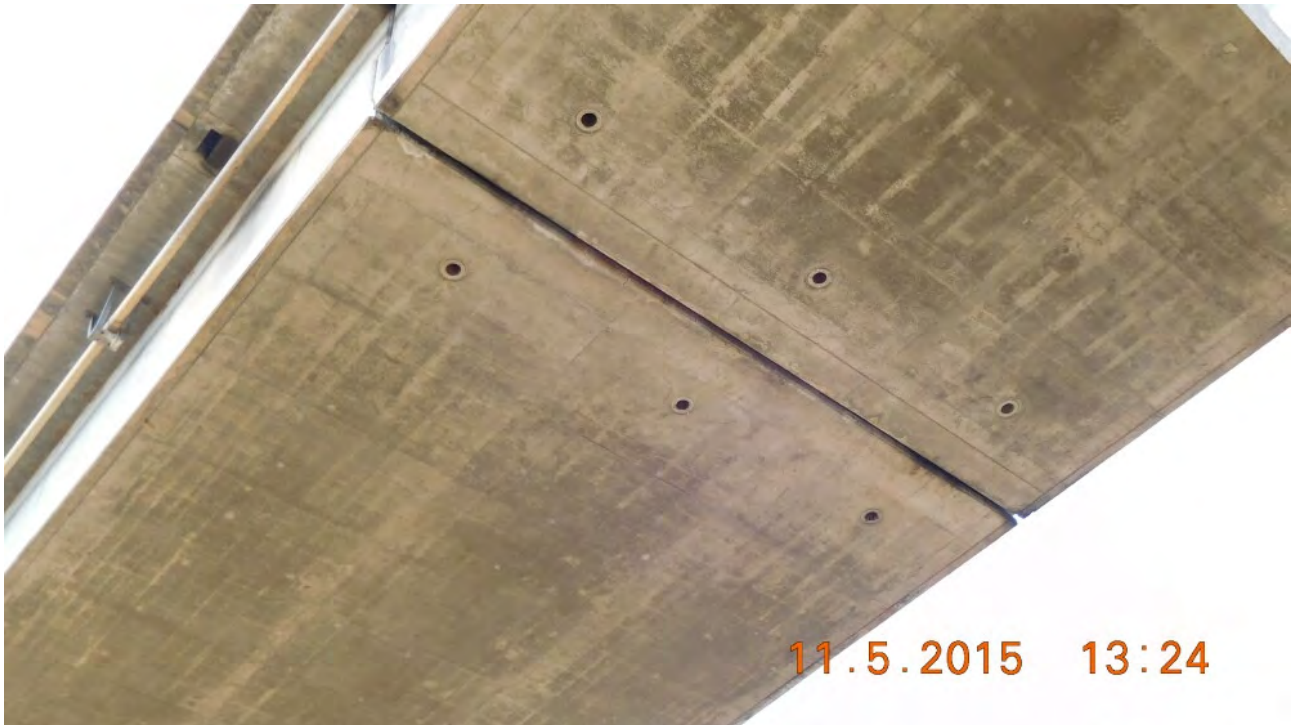
Figure 7. Roosting activity in expansion joints. Unknown whether bats are entering girder interiors through weep holes, but evidence of use by birds was present.

Figure 8. Roosting activity in expansion joints. Unknown whether bats are entering girder interiors through weep holes, but evidence of use by birds was present.

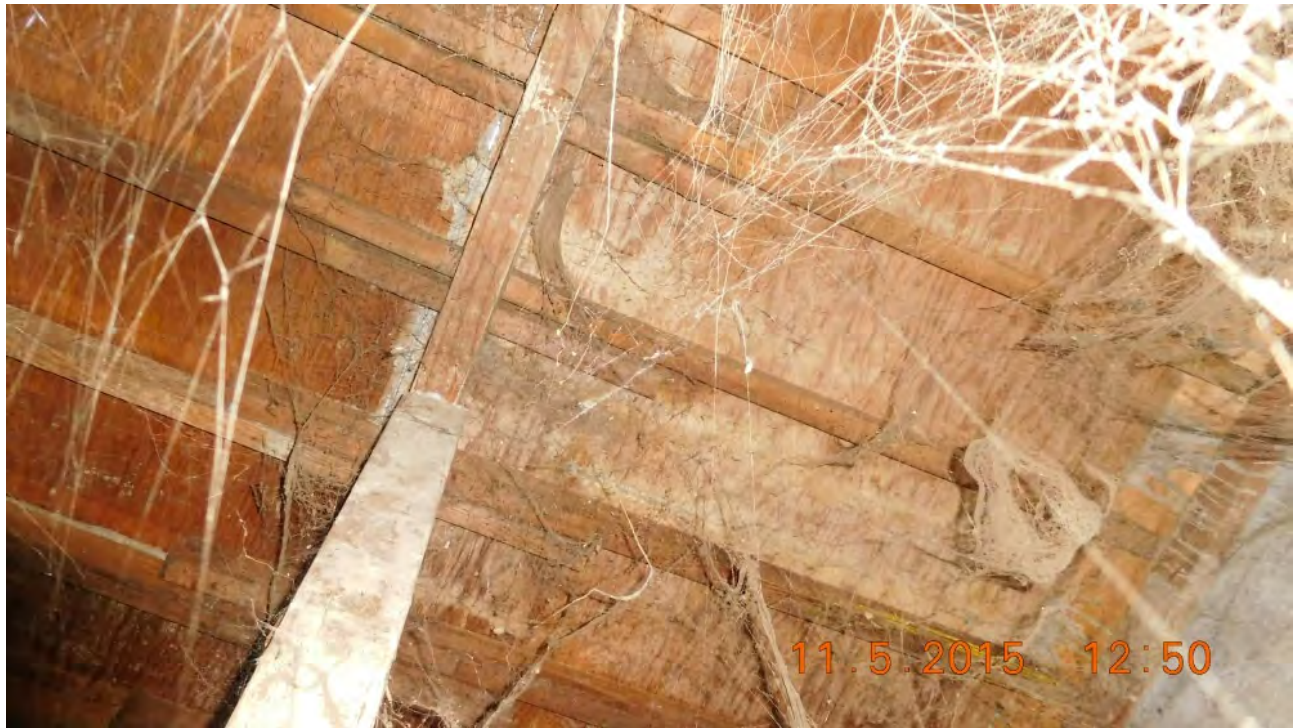
Figure 9. Interior of interior of one girder cell.

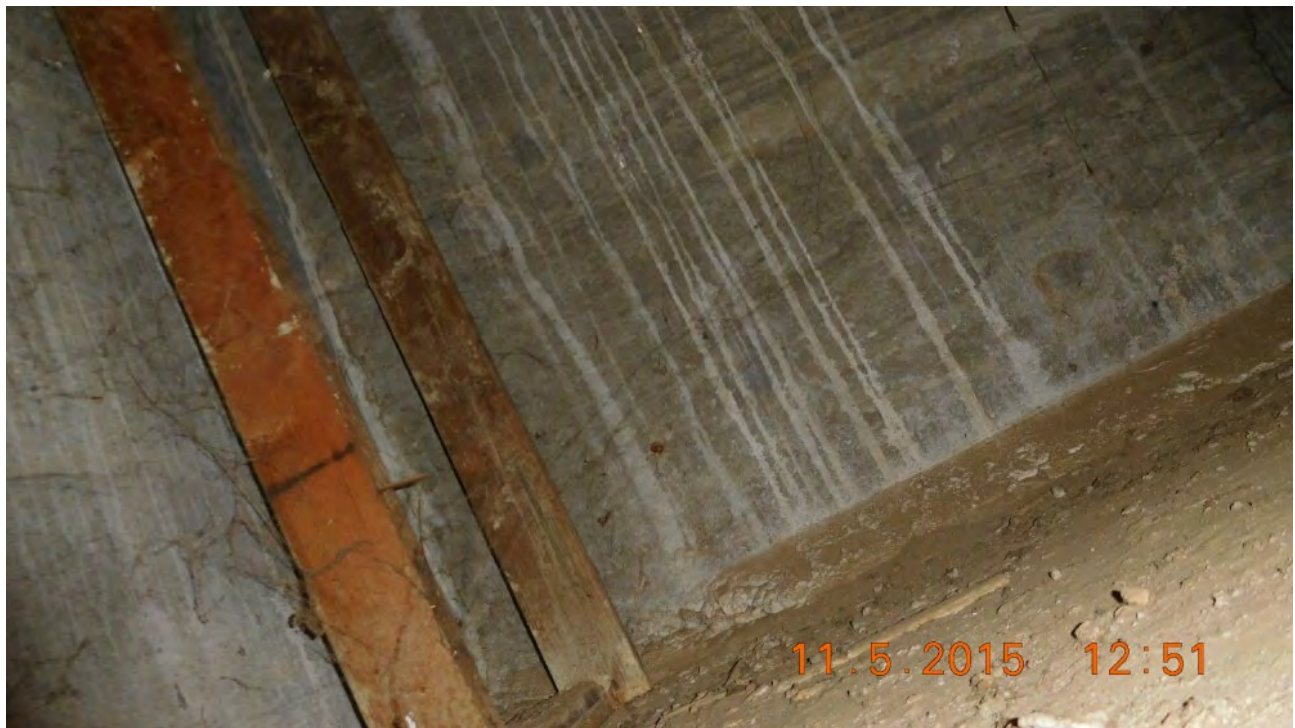
Figure 10. Interior of another girder cell.
